ENGINEERING GEOLOGY ASSESSMENT OF
SLOPE INSTABILITY ON FOREST LANDS
IN SOUTH WESTLAND

A thesis
submitted in partial fulfilment
of the requirements for the Degree
of
Master of Science in Engineering Geology
in the
University of Canterbury
by
MARK J EGGERS

University of Canterbury
1987

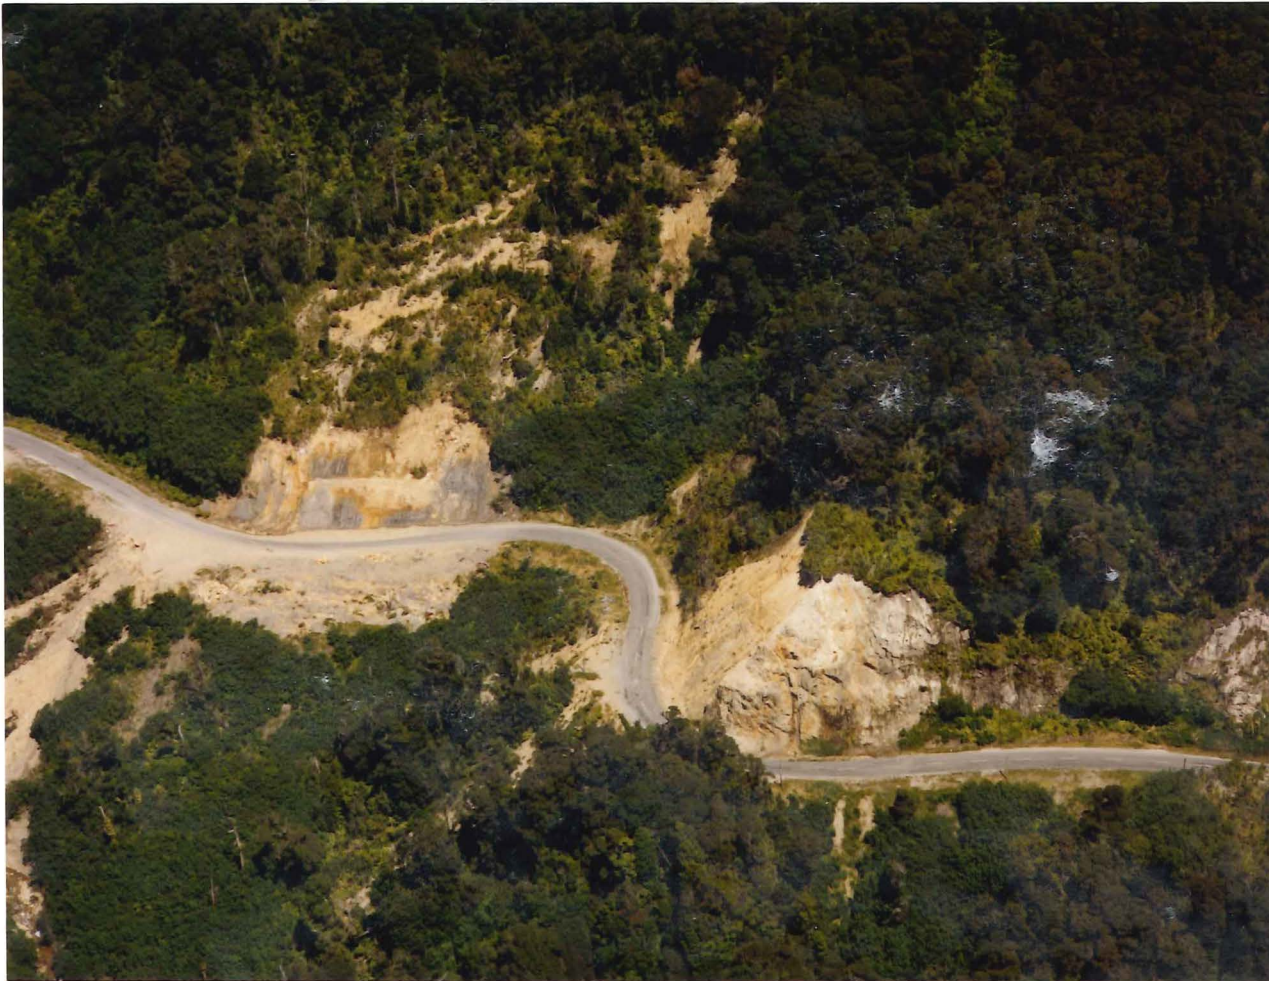
Frontispiece The Grave Earthflow (rotational slide-earthflow complex slope movement type) situated in Cretaceous-Tertiary Hill Country on State Highway 6 between the Whakapohai River and Ship Creek, South Westland. Oblique view looking south-southeast. (N.Z. Geological Survey photo CN 5892b, Photographer: D.L. Homer)

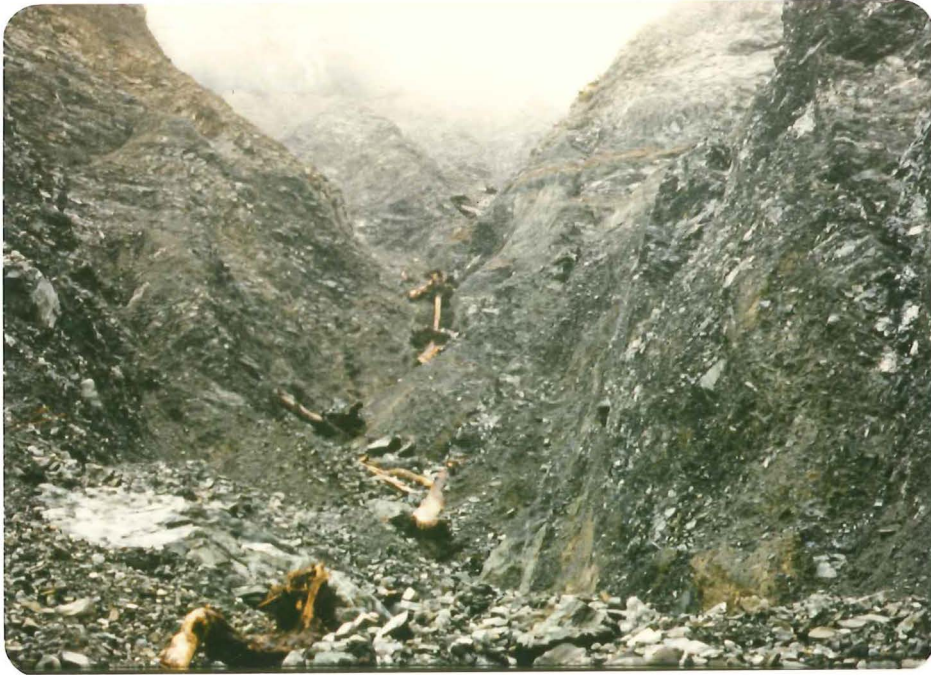
Fig. 4.12 Extensive gully erosion in crushed hornfelsed sandstone bedrock at the top of the escarpment gully complex at BE 11. Vertical elevation from streambed (bottom of photograph) to top of escarpment slope approx. 150m.

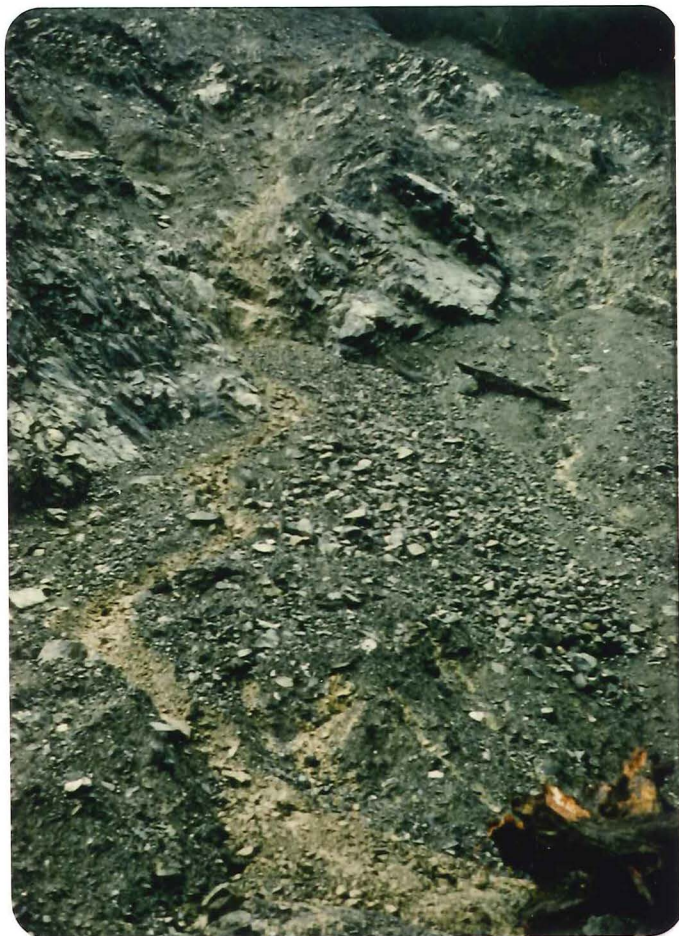
Fig. 4.18 Debris slide-avalanche in crushed hornfelsed sandstone bedrock at locality BE 6: failure was initiated by debris sliding on upper crushed bedrock escarpment slopes which degenerated into an avalanche of falling blocks and flowing debris on lower debris accumulation slopes.

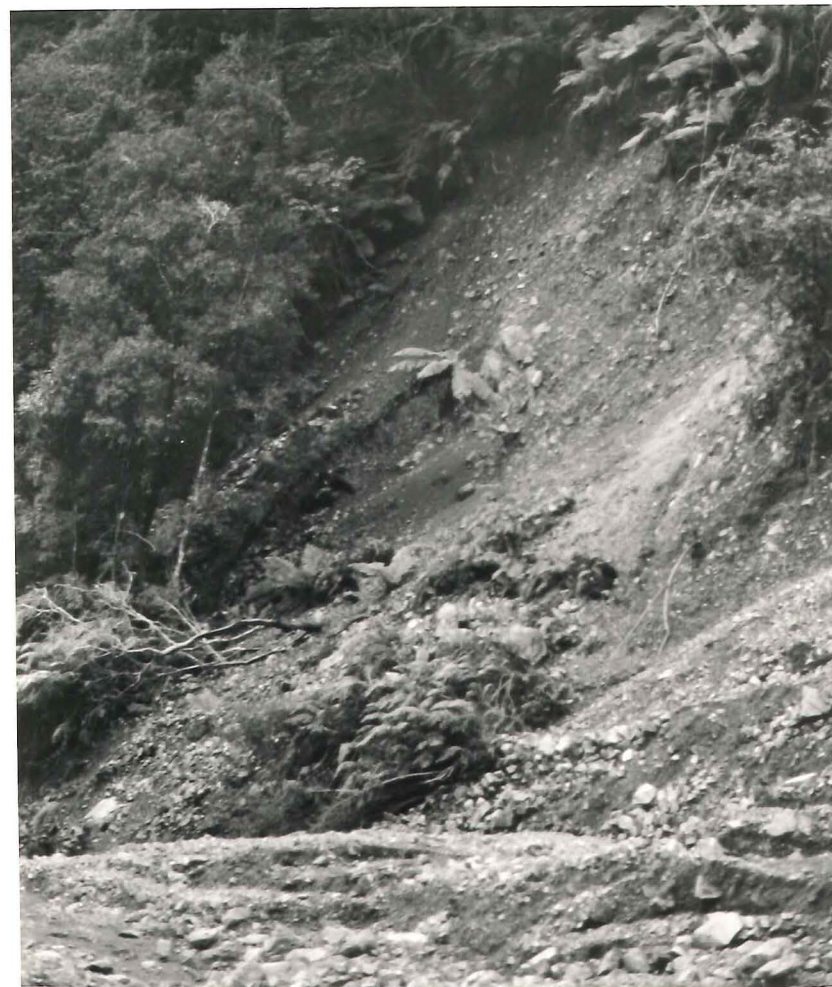
Fig. 4.19 Shallow debris sliding of the forested regolith/colluvium cover at locality BE 2: rafts of vegetation have detached from the slope above the escarpment head and moved down and over the crushed bedrock.

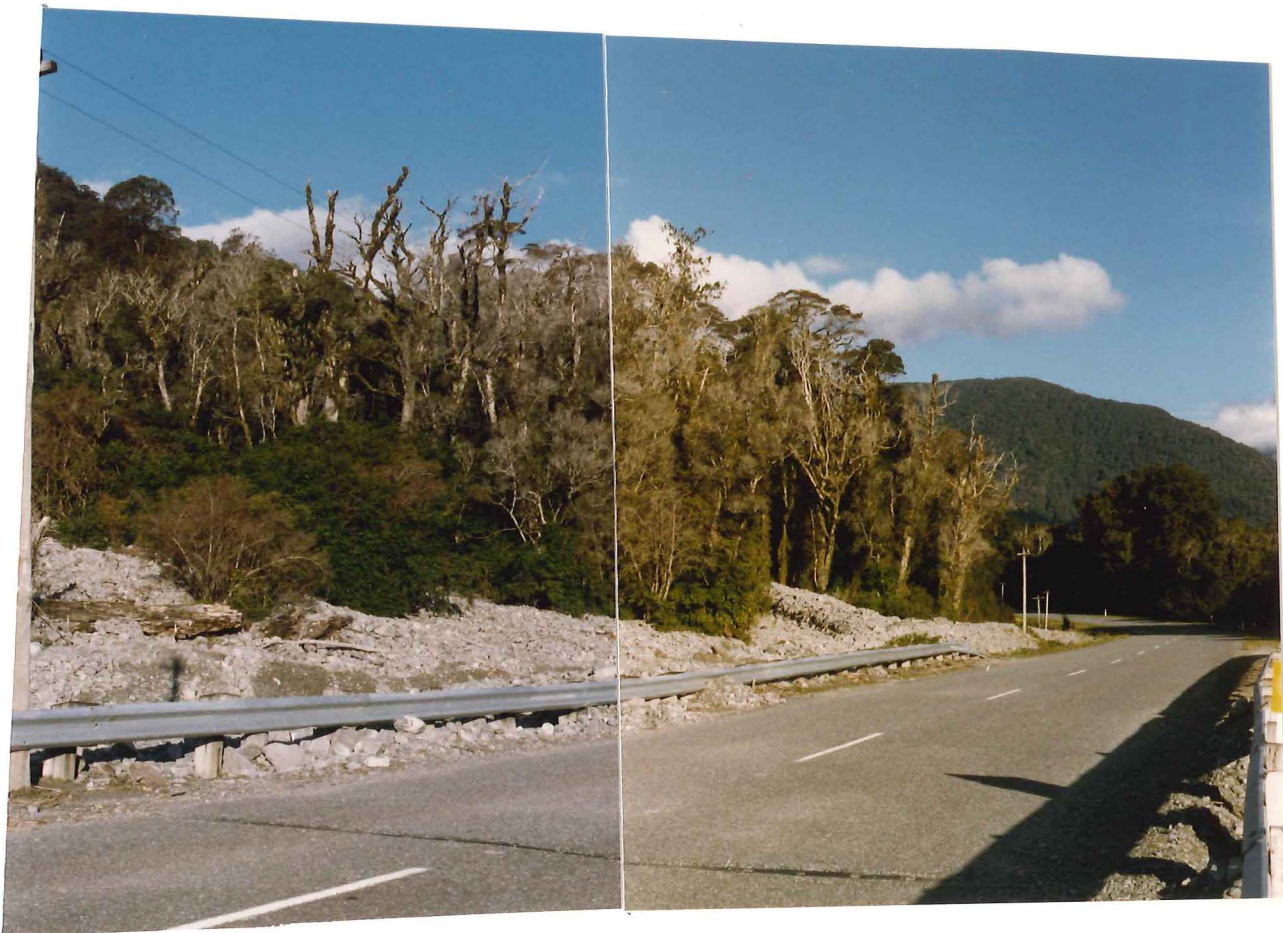
Fig. 4.26 Deposition of stream gravels immediately adjacent to the southeastern bridge road approach by unstable stream channels during high flow.

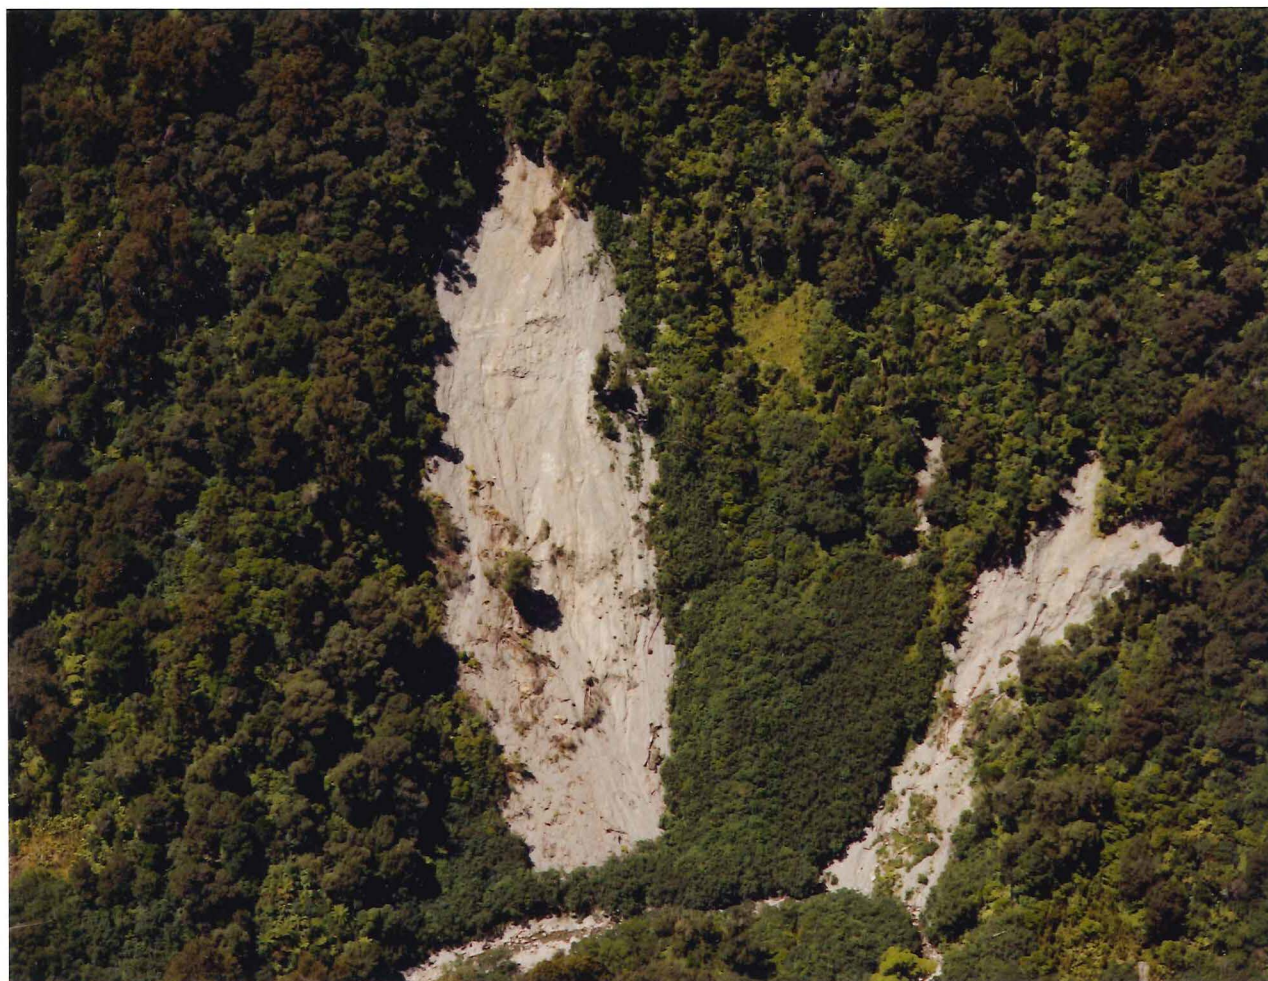
Fig. 4.29 Shallow debris slide-avalanche failures over Greenland Group bedrock on slopes up to 40m high at Mistake Creek, Whakapohai River catchment. Oblique view looking south-east. (N.Z. Geological Survey photo CN 5917a, photographer: D.L. Homer)

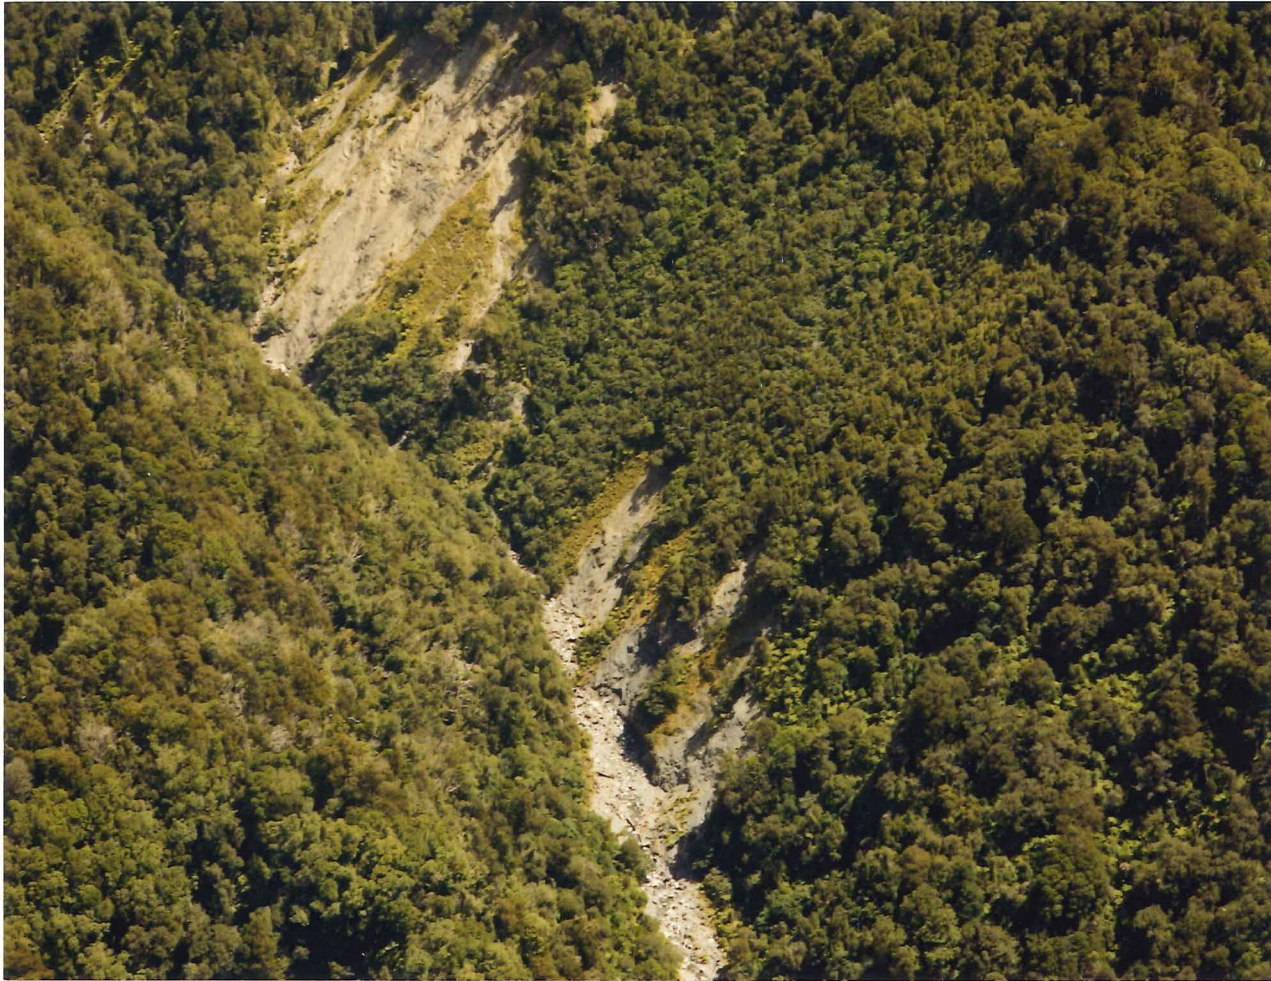
Fig. 4.30 Shallow debris slide-avalanche failures over Greenland Group bedrock on slopes up to 30m high at Power Creek. Oblique view looking west. (N.Z. Geological Survey photo CN 5887b, photographer: D.L. Homer)

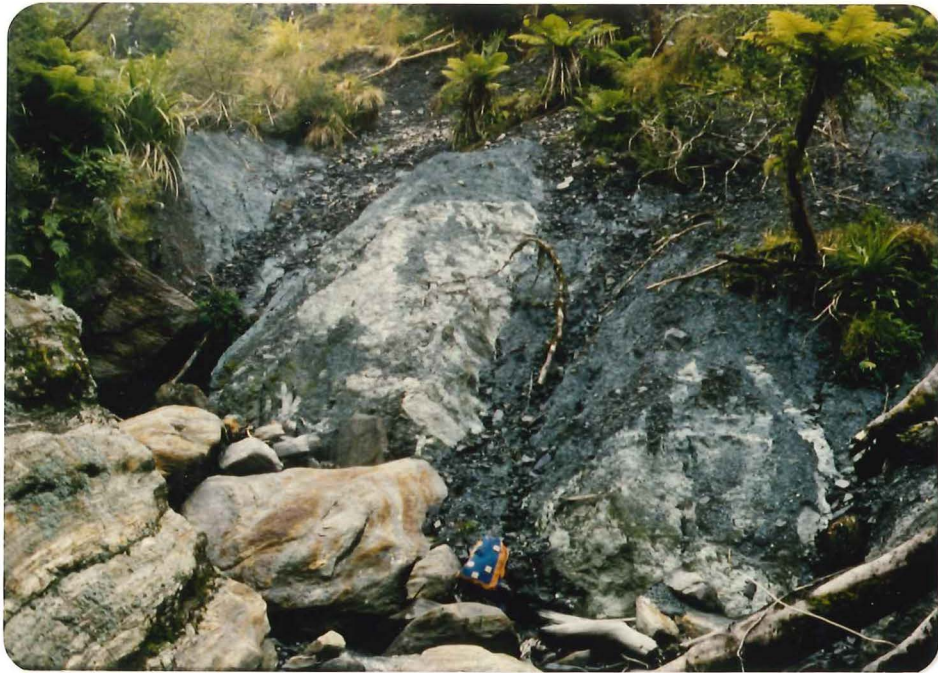
Fig. 5.4 "Rafts" of vegetation sliding over wet to saturated gouge material which is flowing onto the streambed and covering stream boulders.

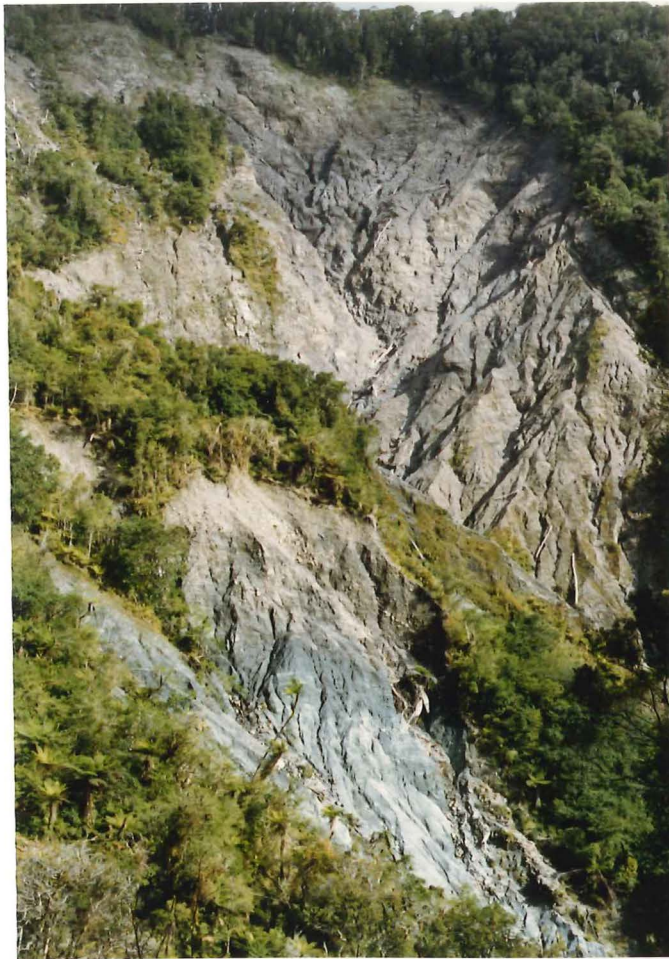
Fig. 5.10 Eroding western flank of the large rock slide at locality HE 6, and crushed mylonite schist at locality HE 7 (foreground).

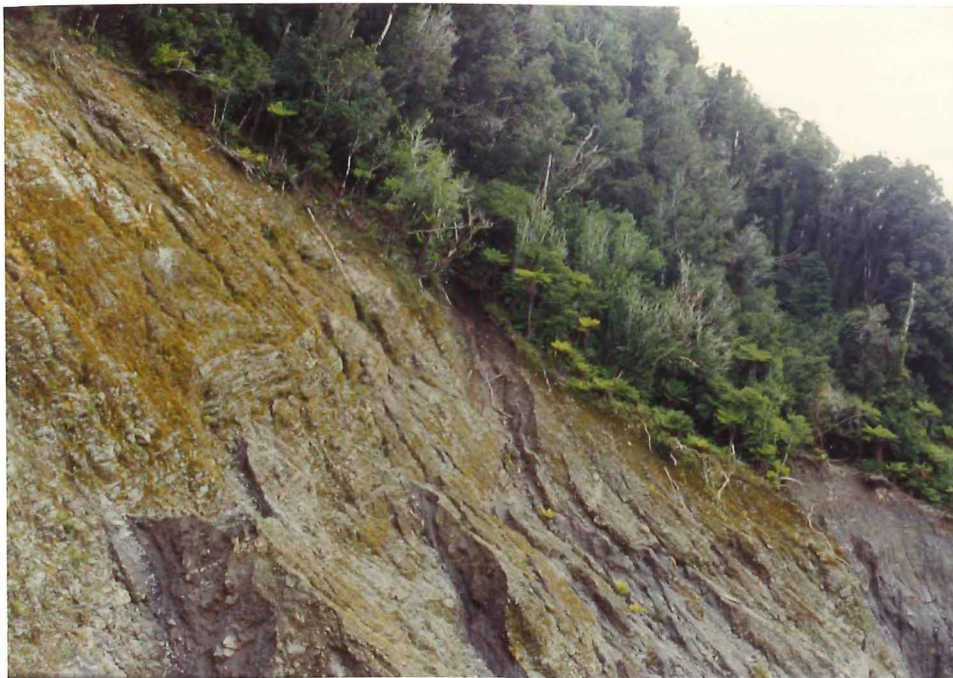
Fig. 5.11 Approx. 20m high headscarp of rock slide at HE 6 with the base of the scarp marked by the tops of sharp ridges of debris, remnant of a formerly more extensive slope before post-failure erosion.

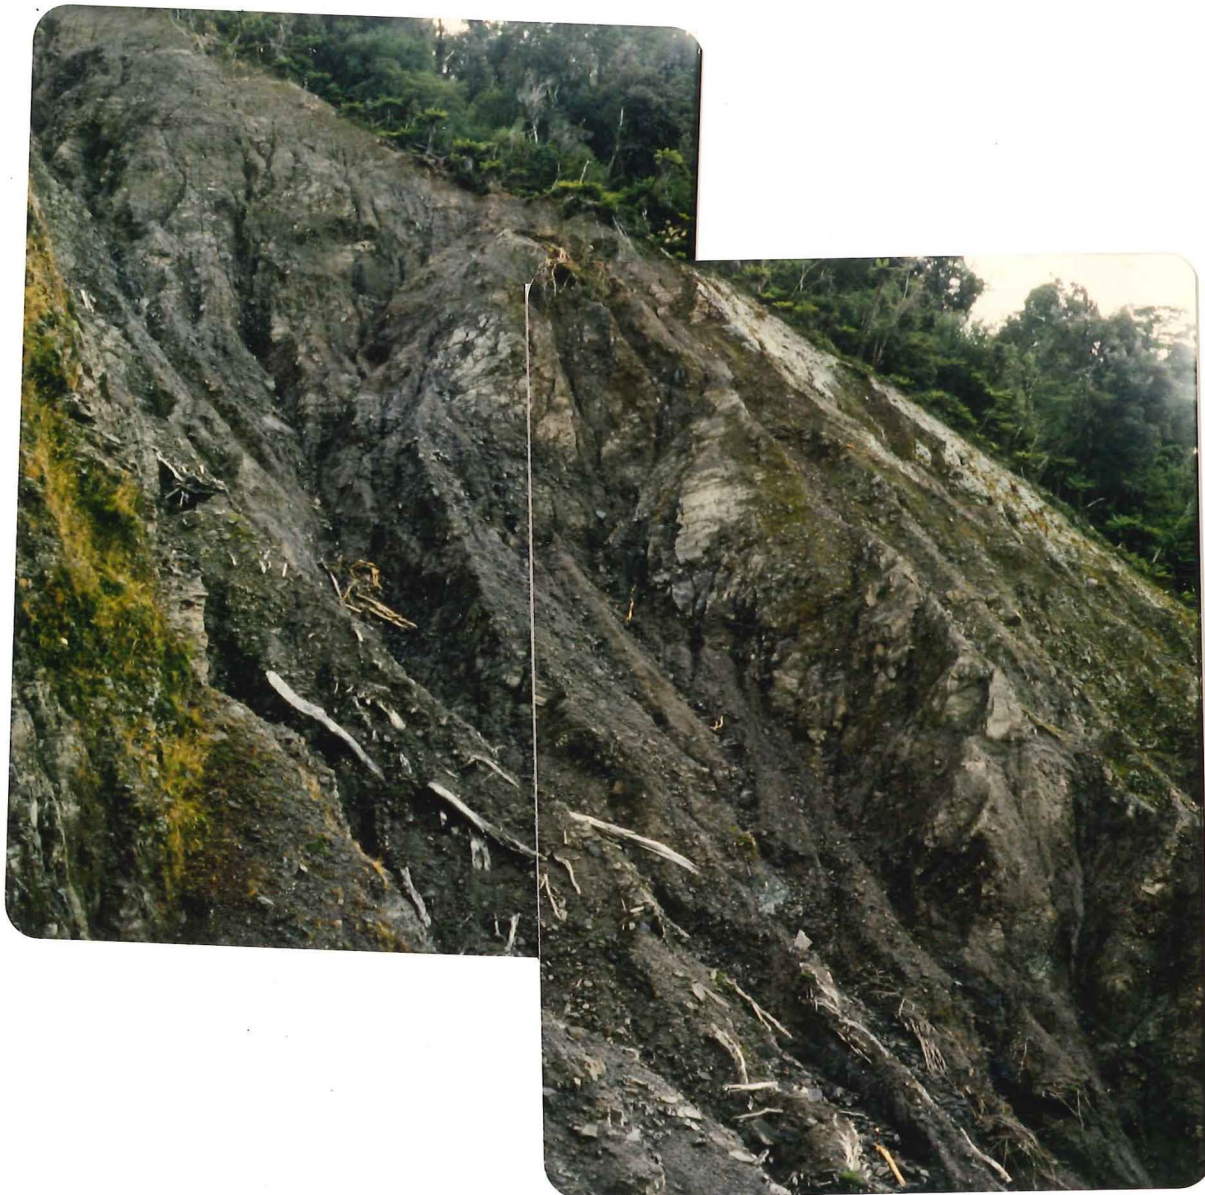
Fig. 5.12 Eroding western flank of large rock slide with "pinnacles" of crushed rock and sag deposits in between indicating extension and loosening of the rock mass along defects.

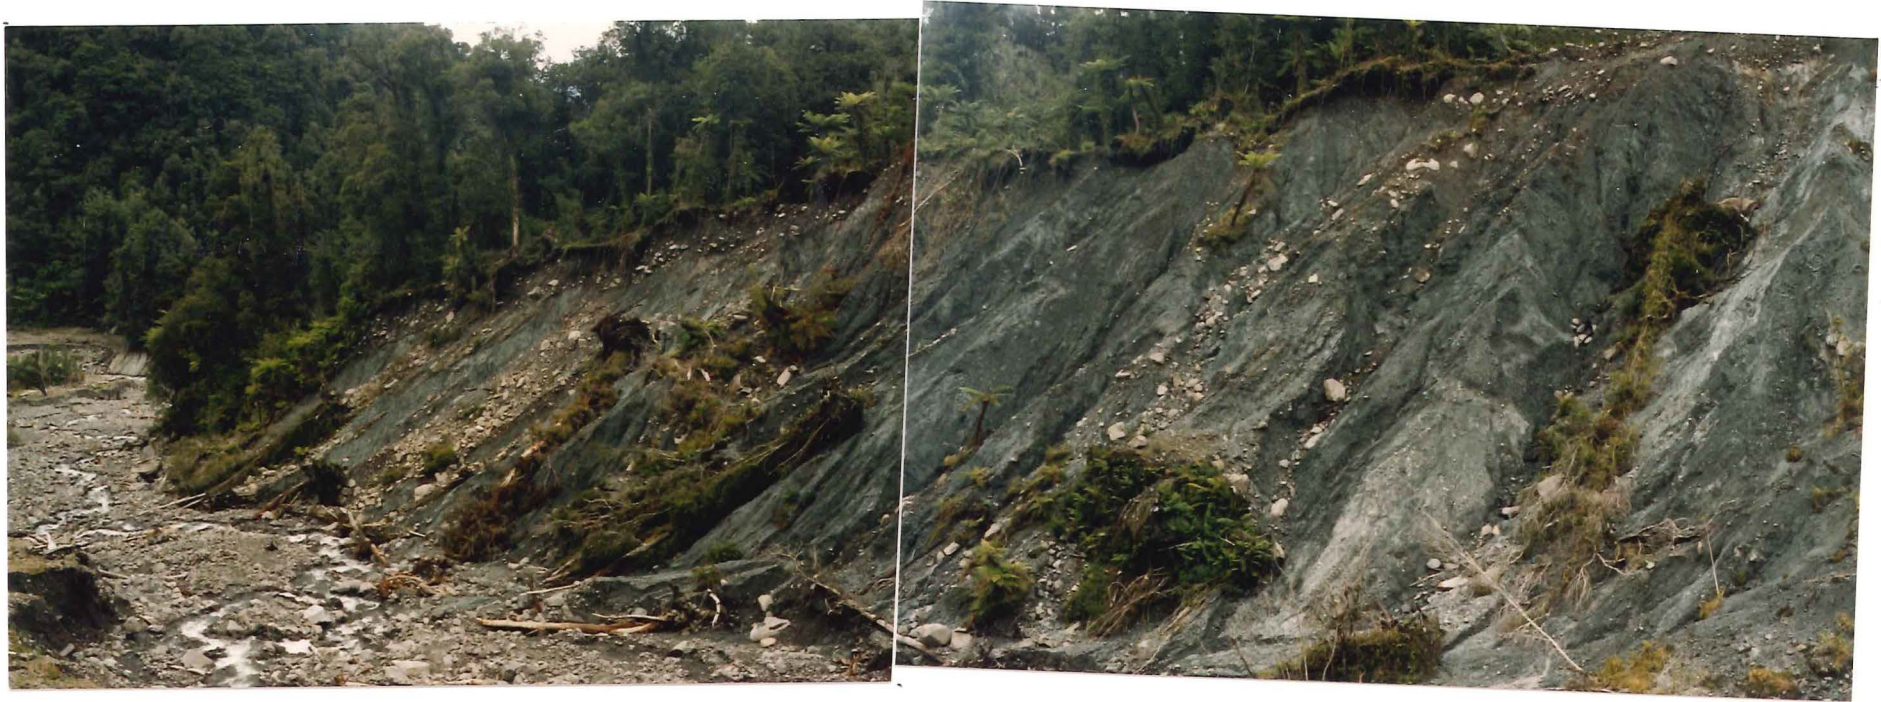
Fig. 5.16 150m long shallow debris slide failure scar in puggy tectonic breccia at locality HE 2 which has been dissected by post-failure gully erosion.

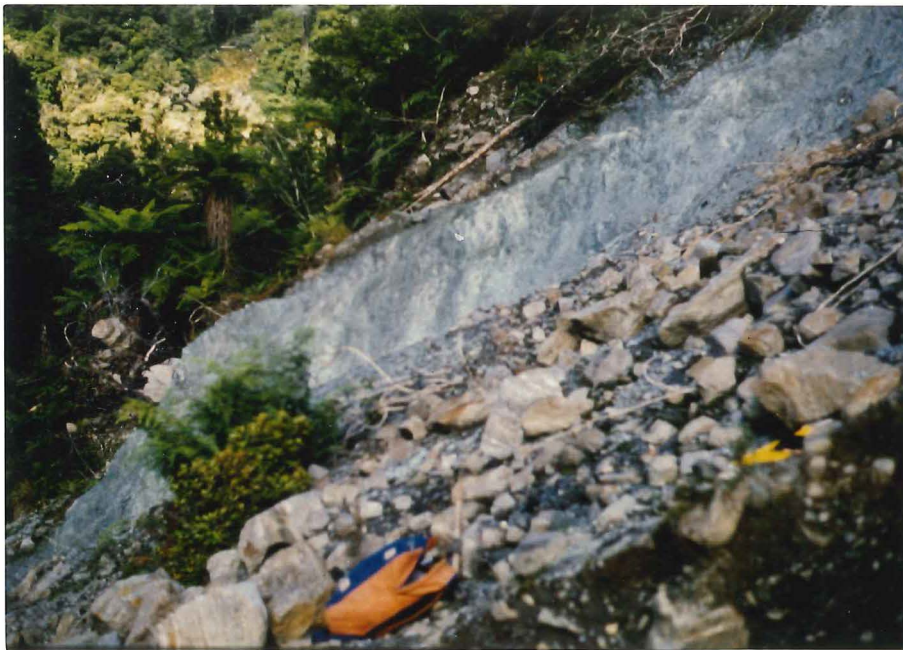
Fig. 5.17 Remnant initial failure surface preserved on sharp ridge on dissected shallow debris slide failure scar at locality HE 2.

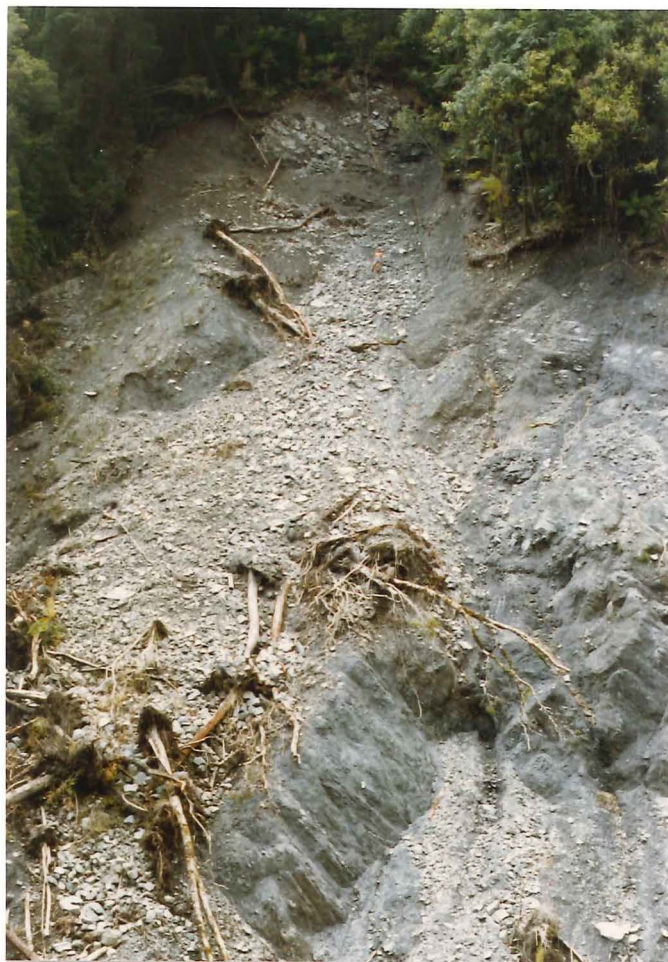
Fig. 5.20 Debris slide-avalanche in crushed mylonite schist in the Alpine Fault Zone at Bullock Creek (person at top of slide scar for scale).

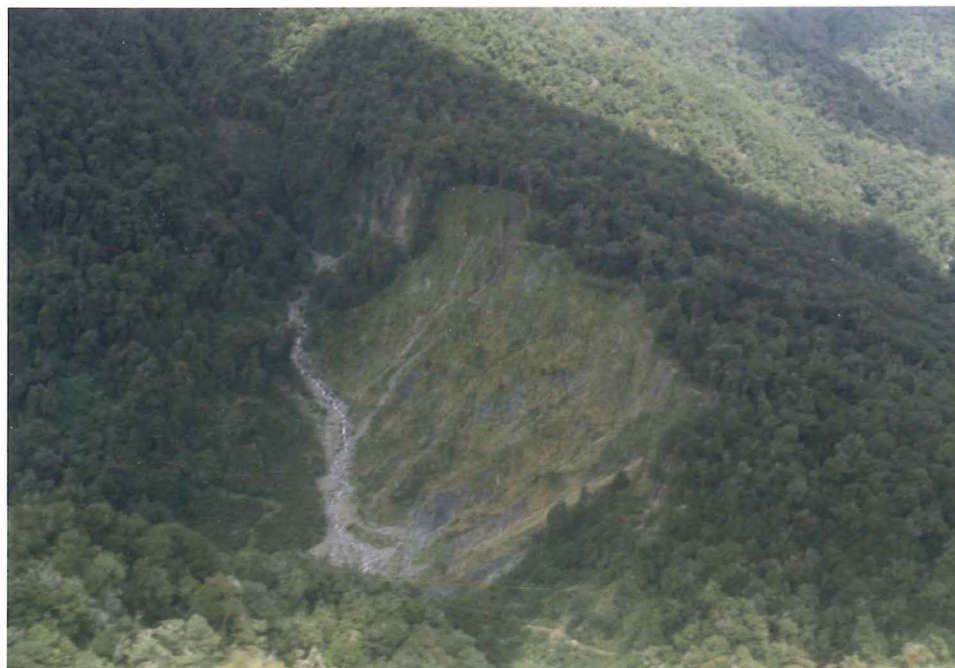
Fig. 5.23 Slope failure scarp (approx. 350m long) in the Alpine Fault Zone at Slippery Face, Robinson Creek. Oblique view looking south-southwest.

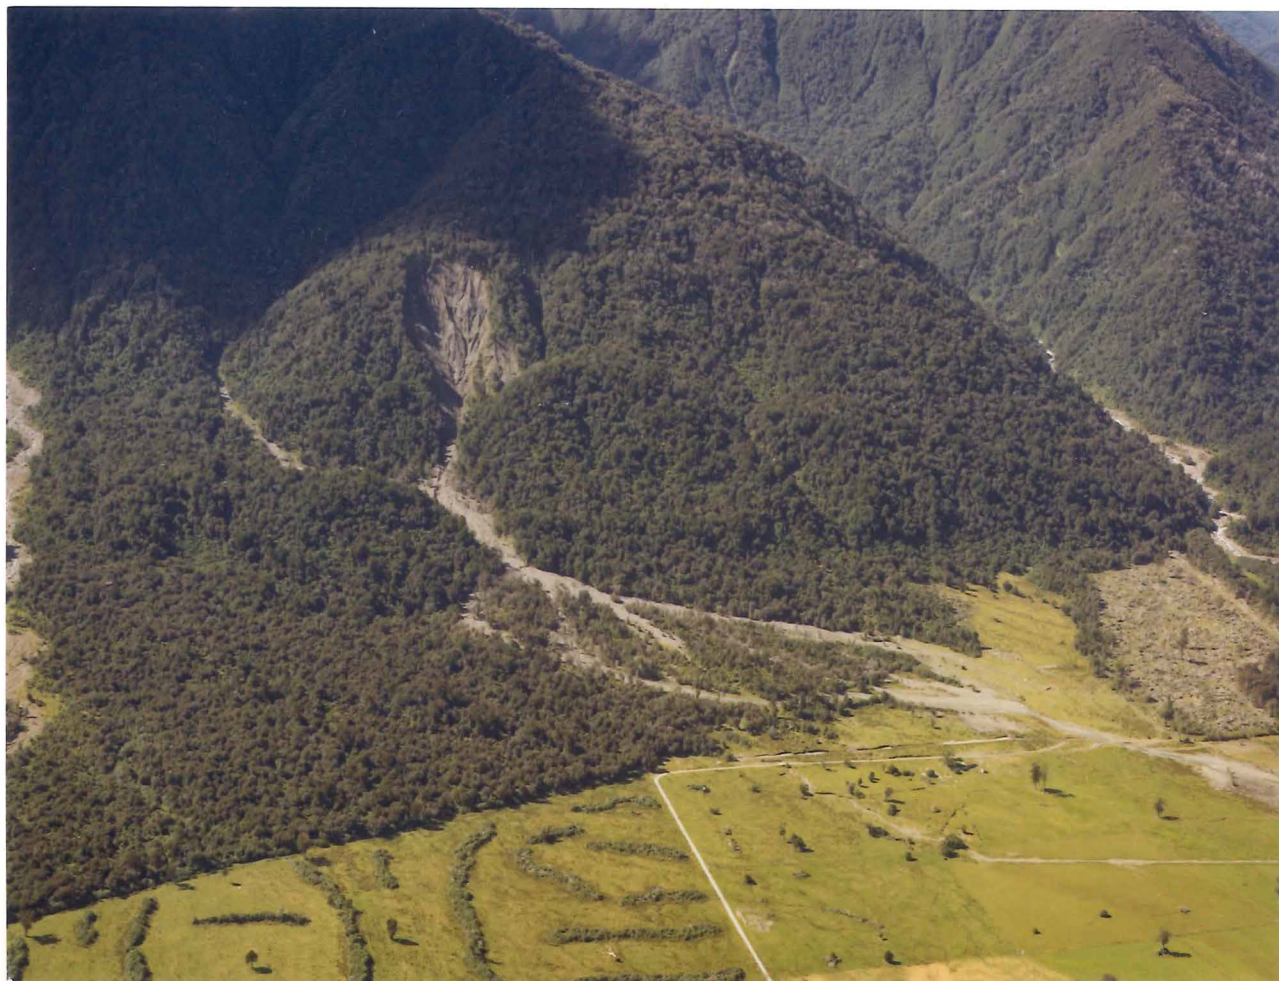
Fig. 5.24 Debris slide-avalanche on fault-bounded mountain front slope in crushed mylonite schist and crushed garnet schist which failed in 1978 producing a debris torrent narrowly missing farm buildings (arrowed). Oblique view looking south-southeast. (N.Z. Geological Survey photo CN 5914a, photographer: D.L. Homer)

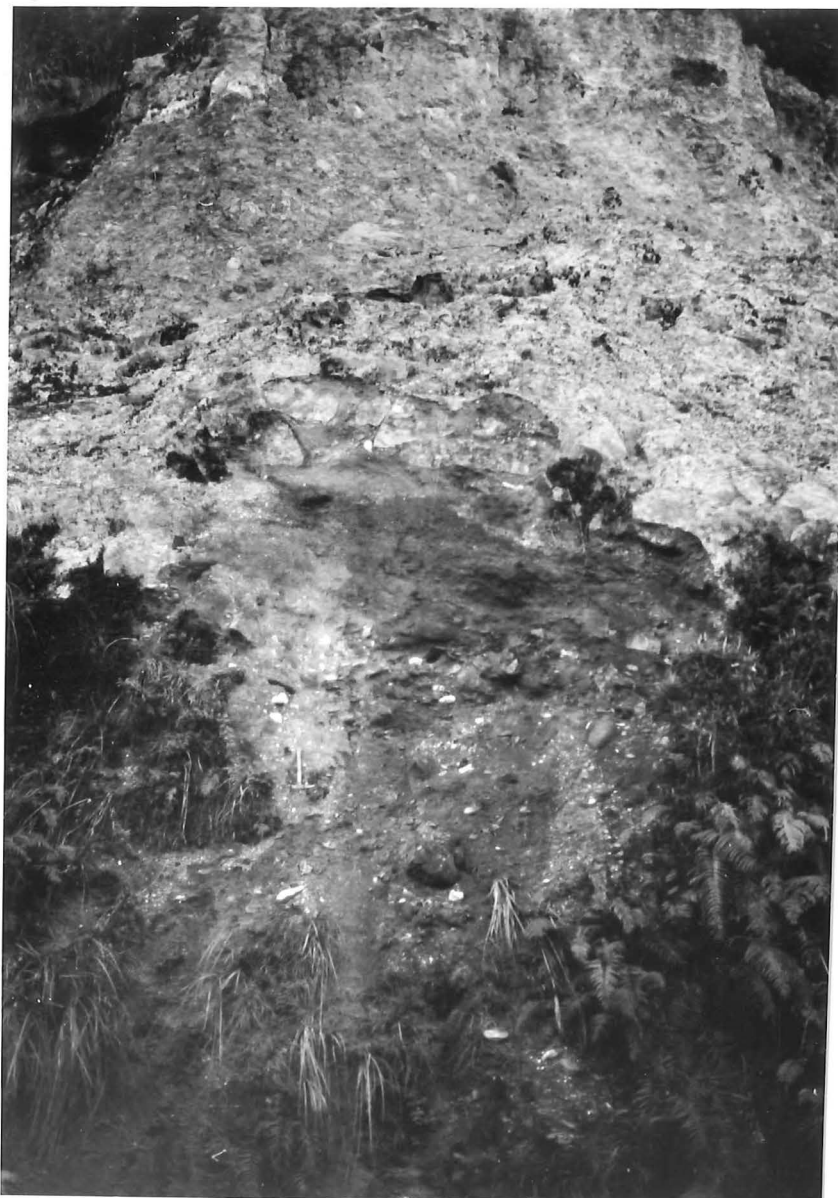
Fig. 6.2 Sandstone colluvium overlying raised beach deposits exposed in failed road batter at the southern approach to Grave Creek along S.H. 6.

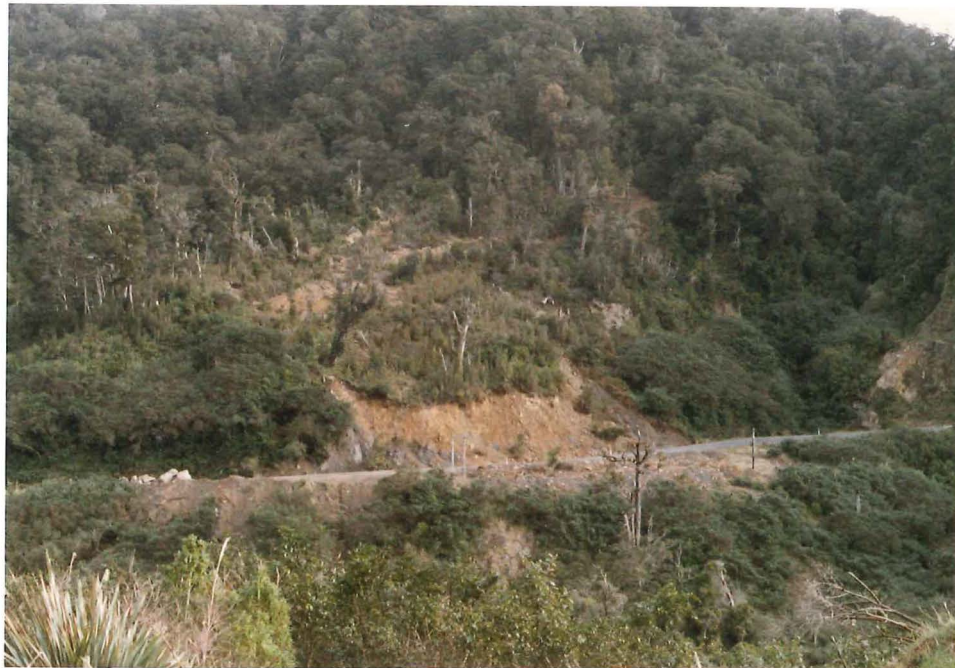
Fig. 6.4 Grave Earthflow in August 1984 before the road batter at the toe of the earthflow was cut and benched.

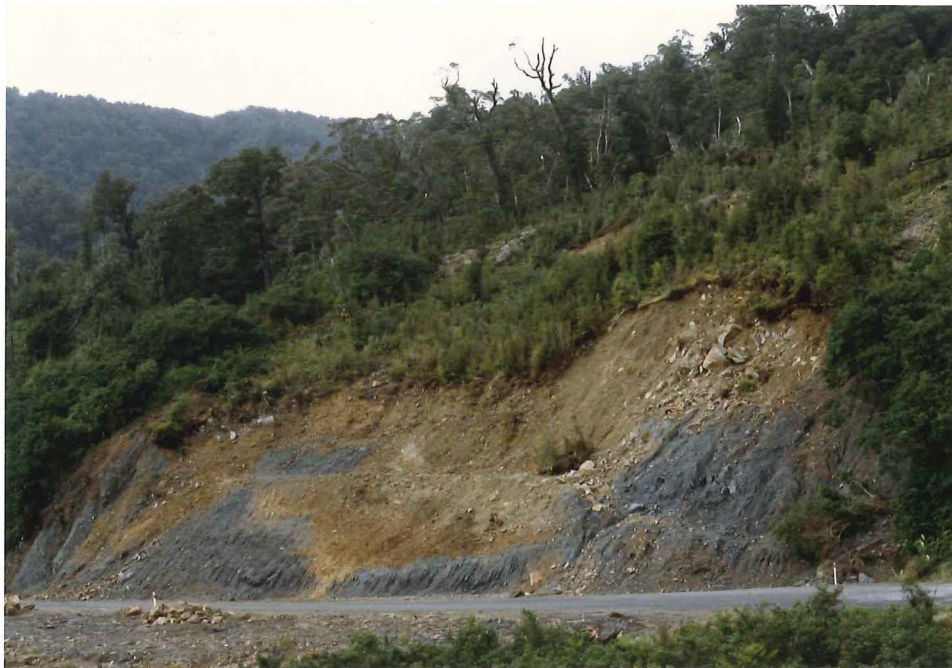
Fig. 6.5 Grave Earthflow in January 1985, one month after the road batter was cut and benched; the batter face was already beginning to degrade by minor sliding of debris onto the bench. Note the wet (darkened) zone immediately above the yellowish brown slide deposit-grey mud boundary.

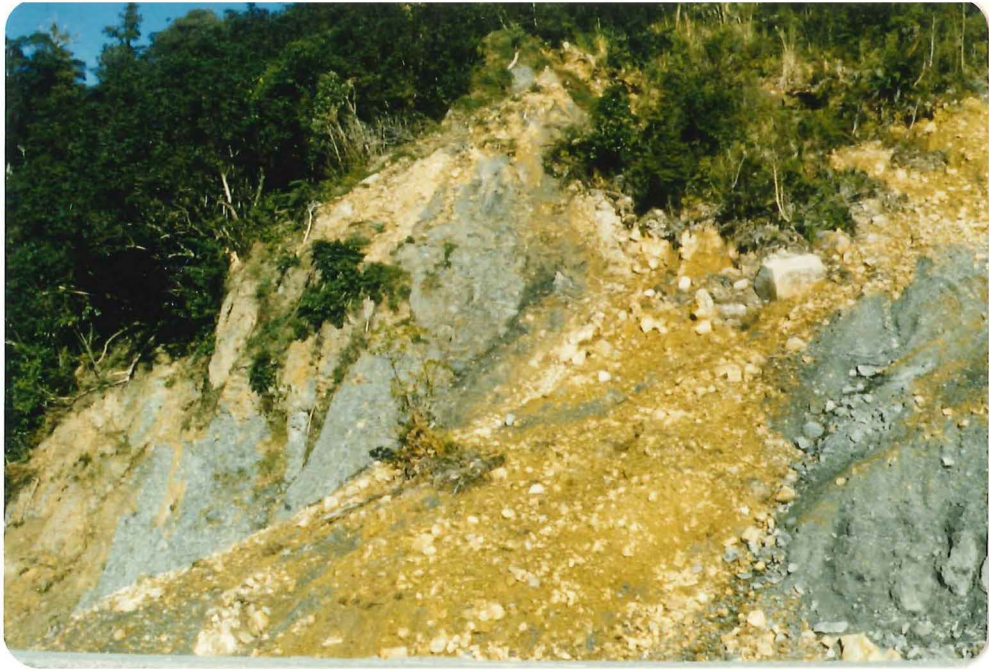
Fig. 6.9 Debris flow lobe approx. 20m wide on the eastern flank of the road batter.

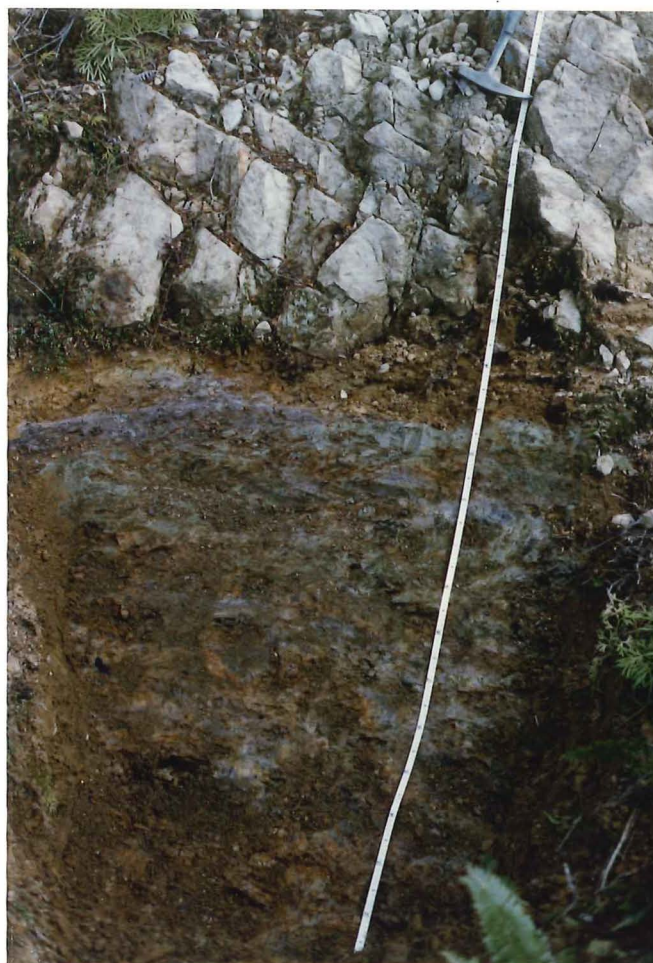
Fig. 6.16 Trial pit GEP 4: highly to completely weathered sand and silt materials underlying broken coal measures sandstone exposed in the head-carp.
